## Beijing storm of July 21, 2012: Observations and reflections

Working Paper 41

Center for Energy and Environmental Policy Research  
Beijing Institute of Technology  
No.5 Zhongguancun South Street, Haidian District  
Beijing 100081  
November 2012

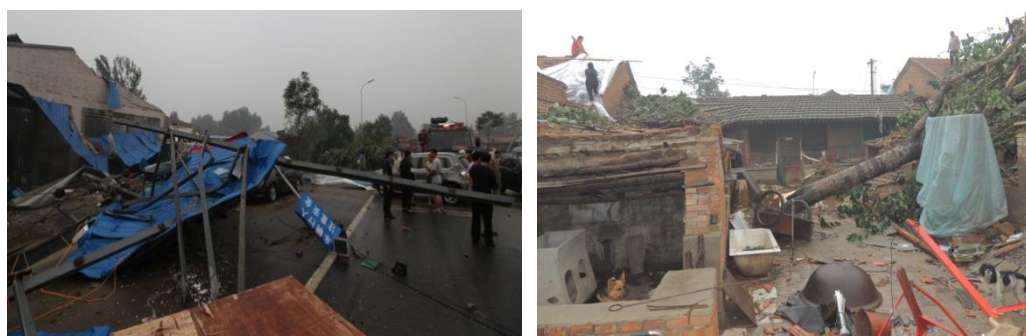
Tongzhou district, which is the lowest area of Beijing, suffered from the torrential rain. During a ten-hour period beginning from 2 pm on July 21, Tongzhou received 152 mm (5.9 inches) of rain on average, in particular, Lu Town received a maximum amount of 190 mm (7.5 inches) of rain. During the same period, a devastating rainstorm-triggered tornado came across some areas, which has caused great damage to infrastructure, in particular, roads and bridges in some places were wrecked, and some were even destroyed. Moreover, plenty of mud brought by upstream floods resulted in sediment being deposited in many channels across Tongzhou District and over 20 small culvert wing walls were wrecked. Pictures shown in Fig.2 reflect the scenes when flood receded, many roads in Daxinzhuang Village were crowded with fallen trees and buildings, resulting in a serious traffic jam and in Fatou Village, houses collapsed and furniture flew out, and even broke into pieces. Overall, the rain-induced flood contributed most to the damages in Tongzhou District.

**Figure 2 Houses in Tongzhou District were destroyed due to the rain-induced flood** (Sources: photos taken by author in Daxinzhuang Village and Fatou Village on the afternoon of July 21, 2012)

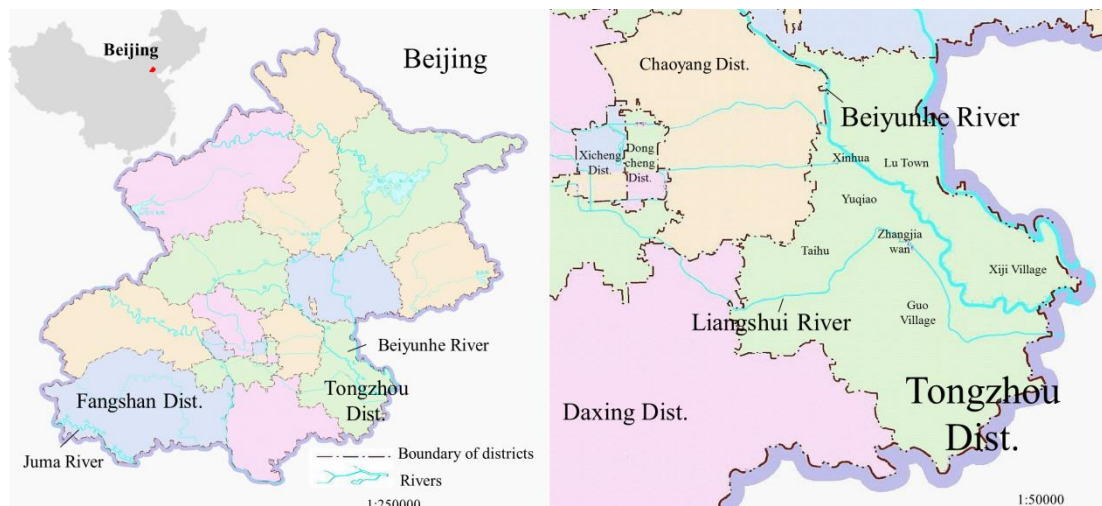
**Figure 3 Geographical map of the area under discussion: the upper-left corner is the map of China; the left side is the map of Beijing and the right side is the map of Tongzhou** (Source: Beijing Municipal Commission of Urban Planning)

Canals played a very important role in discharging floods in this devastating downpour. As one of the five main drainage channels in Beijing (Fig.3), Beiyunhe River which originates from Changping and Haidian areas, stretches south to Tongzhou District, runs through Hebei Province, Wuqing District in Tianjin and finally flows into Haihe River, after a journey of 120 km (74.56 miles). With functions of discharging and water delivering, Beiyunhe River serves as the main branch of Haihe River. The map in the upper-left corner illustrates that Beijing is located in the northeast part of China; the map on the left side marks the location of Tongzhou District and Fangshan District, as well as the rivers mentioned in this article; the map on the right side is enlarged to show the route of Beiyunhe River through Tongzhou District.

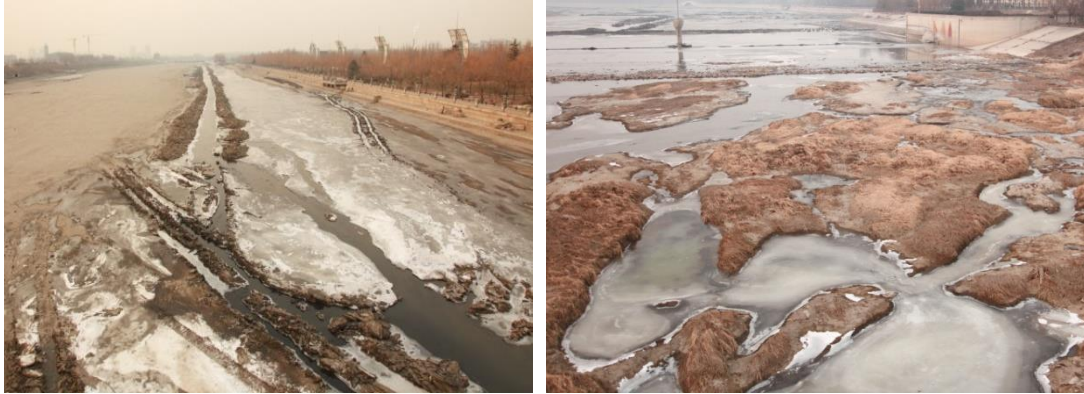
From the relics of some flooded areas, what had happened in July 21 can be deduced. Fig.4 shows that a great amount of mud brought by the city flood has not yet been removed.

**Figure 4** Aftermath of flooded area around Canals in Tongzhou Dist. (Source: photos from left to right were taken of Beiyunhe River bank, Liangshui River on the afternoon of Dec.11 by author)

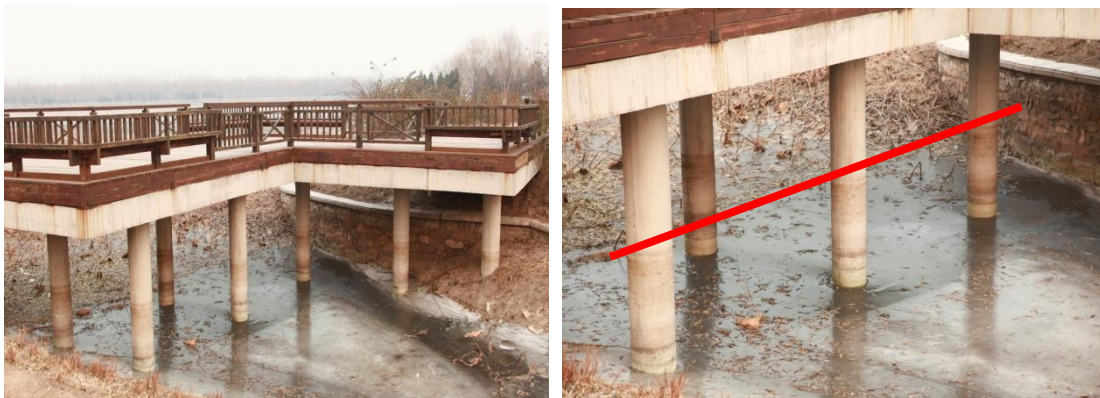
From Fig.5, one can see that the flood almost overtopped the bridge that was newly constructed for tourists. No one died in the flood-triggered events, owing to the prompt evacuation to the Hui Town. Affected people were transferred to an elementary school in the Hui Town for safety until the flood receded. Nonetheless, they were threatened by the water pouring into the school wall, as can be seen by the watermark on the left side of Fig.6. People used sandbags to resist the water to flow up further, as can be seen on the right side of Fig.6.

**Figure 5** Aftermath of Grand Canal Forest Park in Tongzhou Dist.; the red line denotes the height of the maximum flow during the flooding period (Source: photos were taken of the Grand Canal Forest Park on the afternoon of Dec.11 by author)

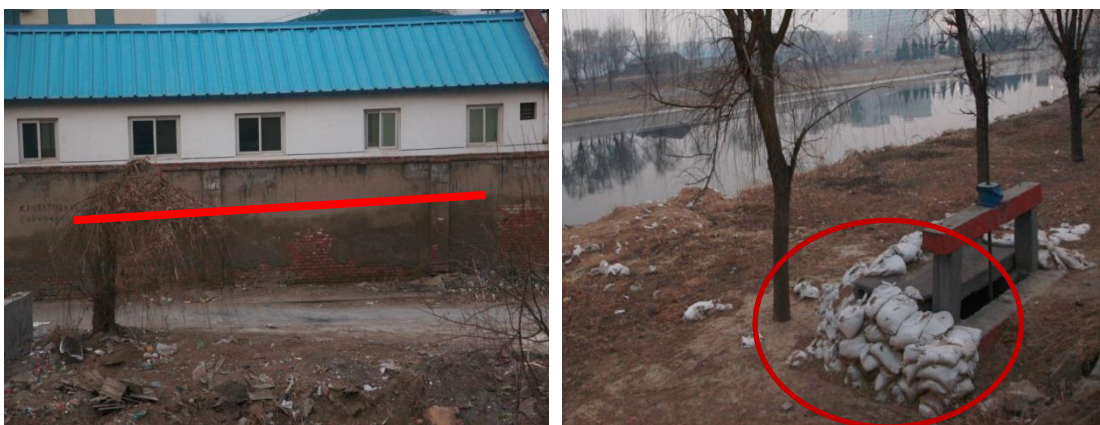
**Figure 6** Aftermath flooding in Hui Town in Tongzhou Dist., the red line marked on the left photo denotes the height of the water flow when the river ran along the school; and the red circle on the right highlights the sandbags which were used to resist the flood (Source: photos were taken of the Hui Town on the afternoon of Dec.11 by author)
